TOMARK, s.r.o.
Division
TOMARKAERO / TOMARKAERO CZ

MANDATORY BULLETIN

Number: ZB SD4-02-2013

Name/Subject: Inspection / replacement of the front landing gear connecting flange

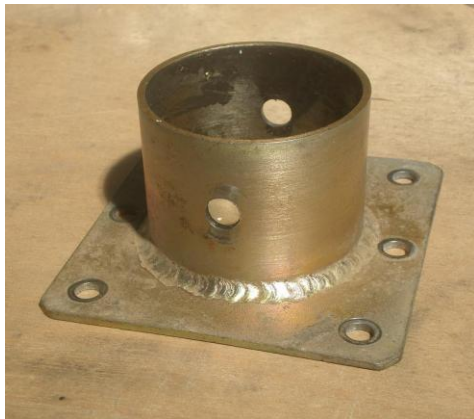
Reason of issuance: occurrence of a cracked weld on the front landing gear connecting flange and its subsequent break

Fig. 1: Flange without strengthening ribs

In the case a flange without strengthening ribs is mounted on the front landing gear leg (Fig. 1 above), before the releasing of the aircraft to service it will be necessary to replace that flange for a new one with strengthening ribs (fig. 2 above).

With a Vernier caliper measure the outer diameter of the front landing gear pipe. It should be either \varnothing 50 mm or \varnothing 50.8 mm. Send the information about the diameter of the front landing gear pipe to TOMARK, s.r.o. at schichman@tomarkaero.com or provide it by phone at +421 905 669 806. TOMARK, s.r.o. will in return send you a new strengthened flange with detailed instructions for its mounting.

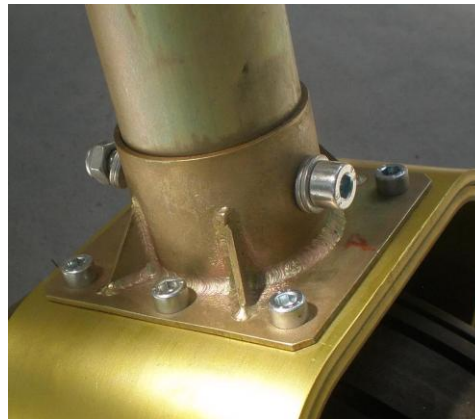
Fig. 2: Flange with strengthening ribs

In the case a flange with strengthening ribs is mounted on the front landing gear leg, visually check the integrity of all welds. In the case of the occurrence of any cracks, send the information to TOMARK, s.r.o. with a possible photo documentation at schichman@tomarkaero.com or provide it by phone at +421 905 669 806. TOMARK, s.r.o. will in return send you a new strengthened flange with detailed instructions for its mounting.

If all welds on the flange with strengthening ribs are intact, it is not necessary to replace the flange. Before the mounting of the covers of the front landing gear leg by the same procedure as specified above in the reverse order, check the tightening of all nuts on the flange.
